SAN FRANCISCO WATER DEPARTMENT
WATER QUALITY DIVISION

Enclosed is my report on the recent Fairchild Plant filter clogging problems. If there are any details you feel should be added to our records or if the report does not comport with your findings please contact me.

DATE: November 16, 1976
SUBJECT: Hatch Hatchy Aqueduct 76:18
FILE: _____

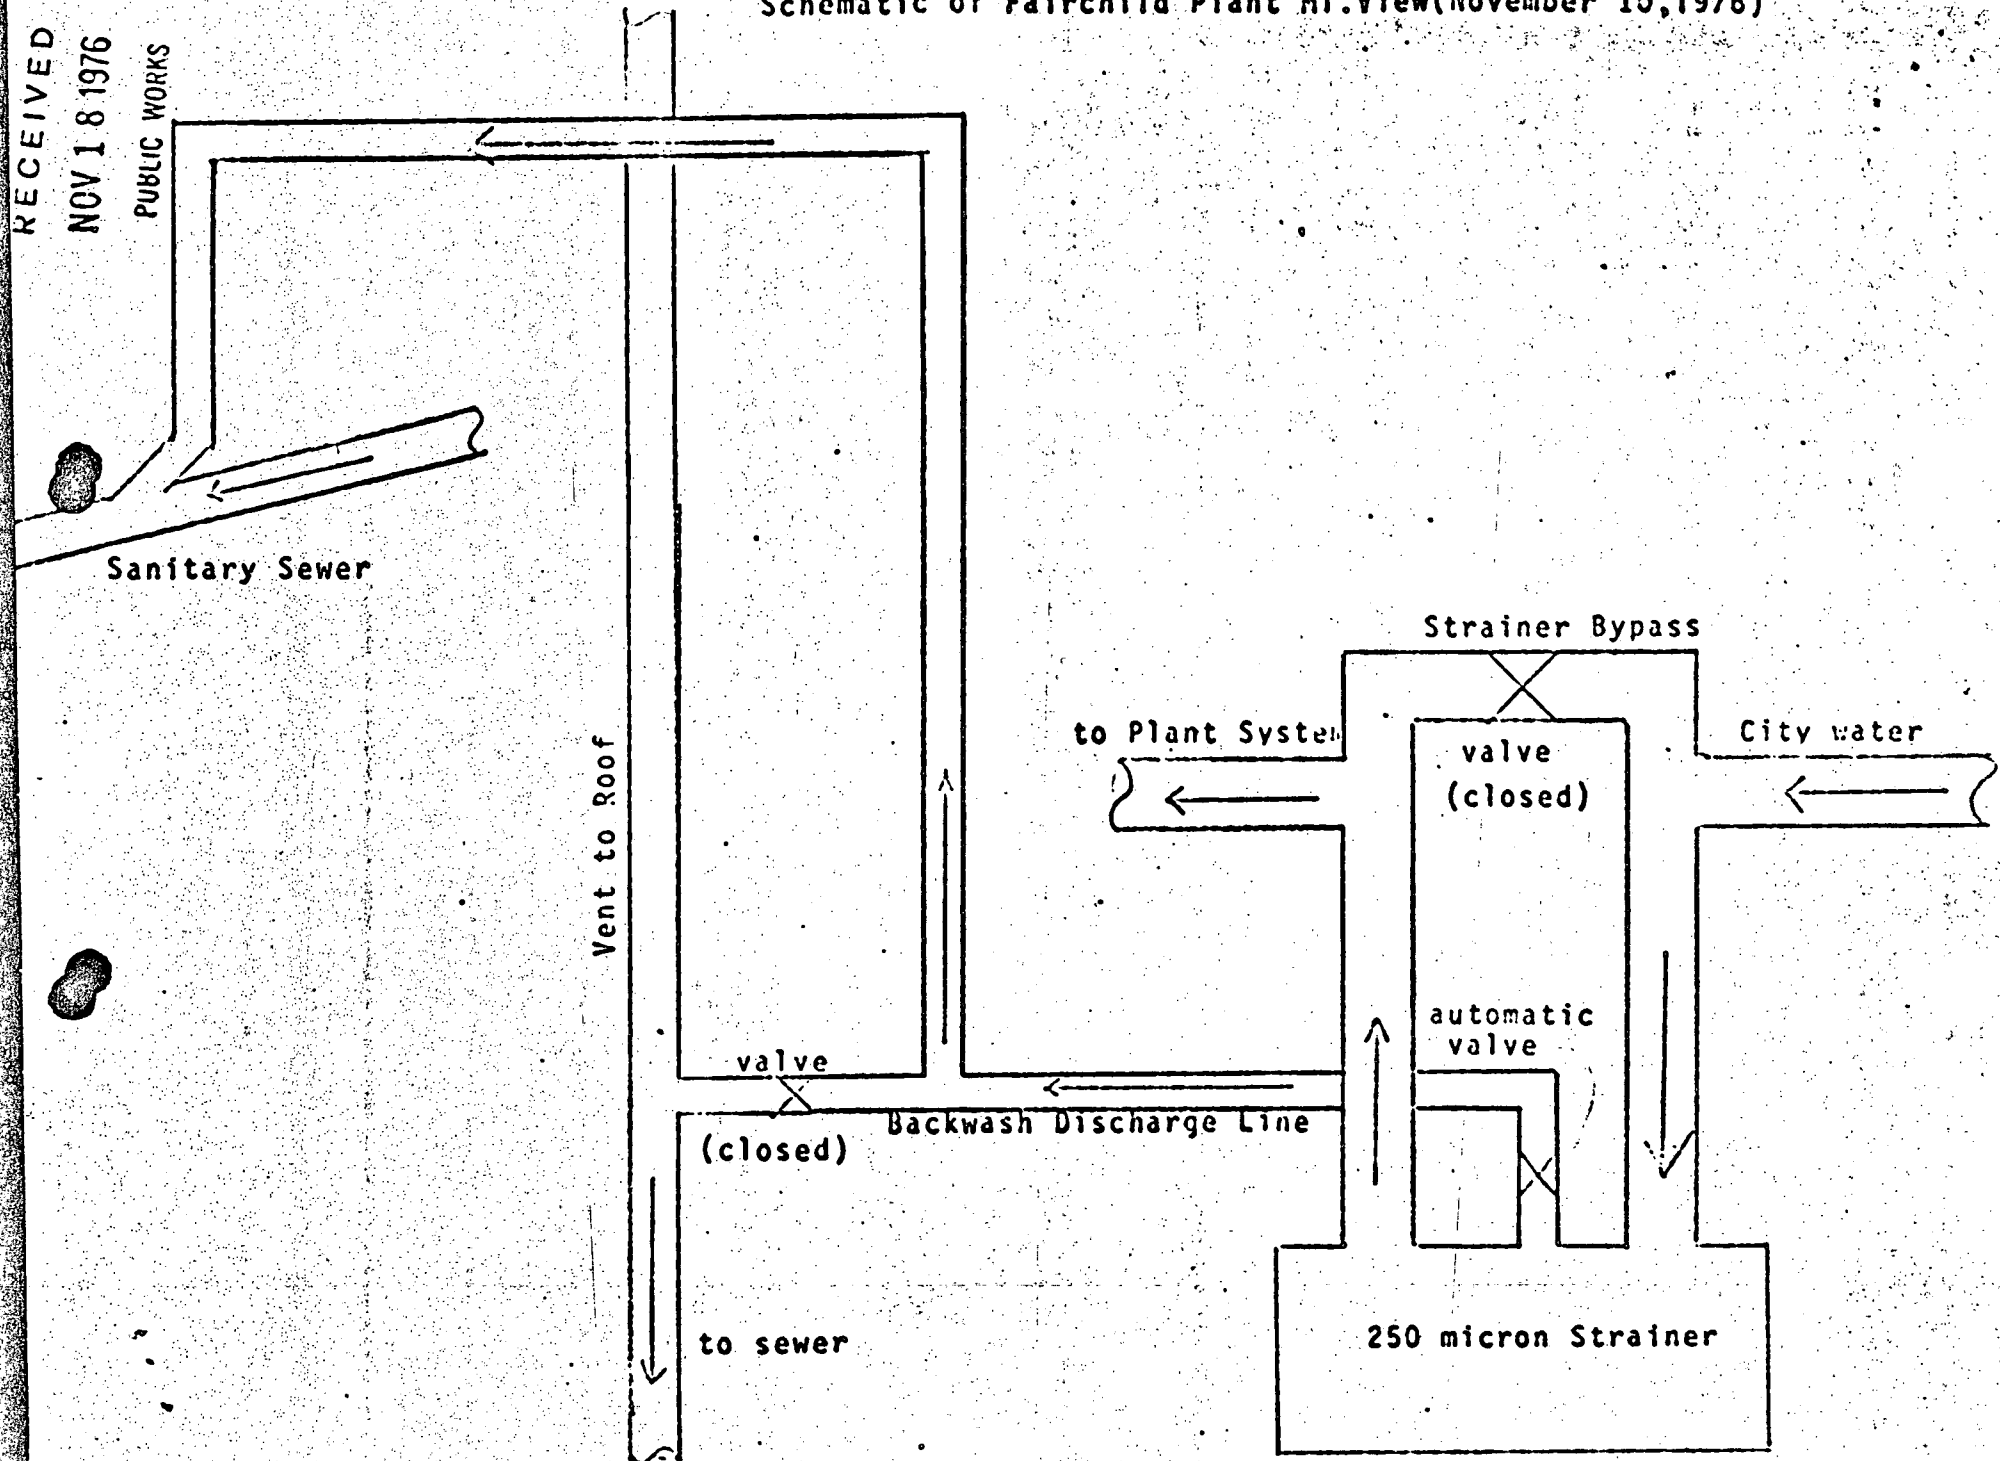
Schematic of Fairchild Plant MT.View(November 10,1976)

We inspected filters from the same area of the plant and these showed no sign of this material and had nothing unusual trapped on them (some sand and algae). We then inspected the strainer on the incoming city water. The strainer was a 250 micron device with a self flushing action. Norm and I both noticed that a newly installed backwash water discharge line was connected to the strainer with no device to prevent backflow of the waste water. A further investigation showed this backwash line connected directly to a sanitary sewer line without any air gap or anti-siphon device. (See diagram.) The potential for back siphonage appeared very great because the sanitary sewer line was 6 to 8 feet higher than the strainer. Norm and I pointed this out to Ms. Boyd and Mr. Yurash. Norm made several specific suggestions on how to correct this dangerous connection. Mr. Yurash assured us that this would be corrected immediately.

It is difficult to come to any definite conclusions in regard to this occurrence. It seems to be isolated to the Fairchild Plant but we did not conduct a wide scale investigation of other possible plant areas. There is a definite cross connection from the strainer backwash line to a sanitary sewer but there was no evidence to show that this problem was caused by introduction of sewage into the drinking water. The idea of a "dead end" in the system seems to be the best possible answer although we did not find such a "dead end". Norm hypothesized an "operational dead end" (my words not his) in the mains that loop around the industrial complex. But again, we had no evidence to draw any firm conclusion. Finally, I see this as a problem not directly related to our water supply or operations.
